Levee failure mechanisms during the extreme rainfall event: a case study in Southern Taiwan

Wen-Chao Huang · Meng-Chia Weng · Ray-Kuo Chen

Abstract Extreme weather has recently caused many disasters worldwide. In August 8, 2009, Southern Taiwan suffered from serious floods during Typhoon Morakot. In this extreme rainfall event, the Chiuliao first levee in the Laonong River basin experienced catastrophic failure. Therefore, this study focuses on the levee failure mechanisms based on variations in levee water levels. Specifically, this study investigates four mechanisms based on limit state equilibrium. The first mechanism involves the slope stability under hydrostatic conditions at various water levels. The results of this analysis show that the levee cannot fail under this mechanism. The second mechanism involves the levee slope stability with steady-state seepage. Because the water levels are different on the protected and flood sides, the water recedes much faster on the flood side than the protected side. Based on this analysis, the levee slope might fail when the water level at the protected side is close to the top of levee and the water level at the flood side starts to rec

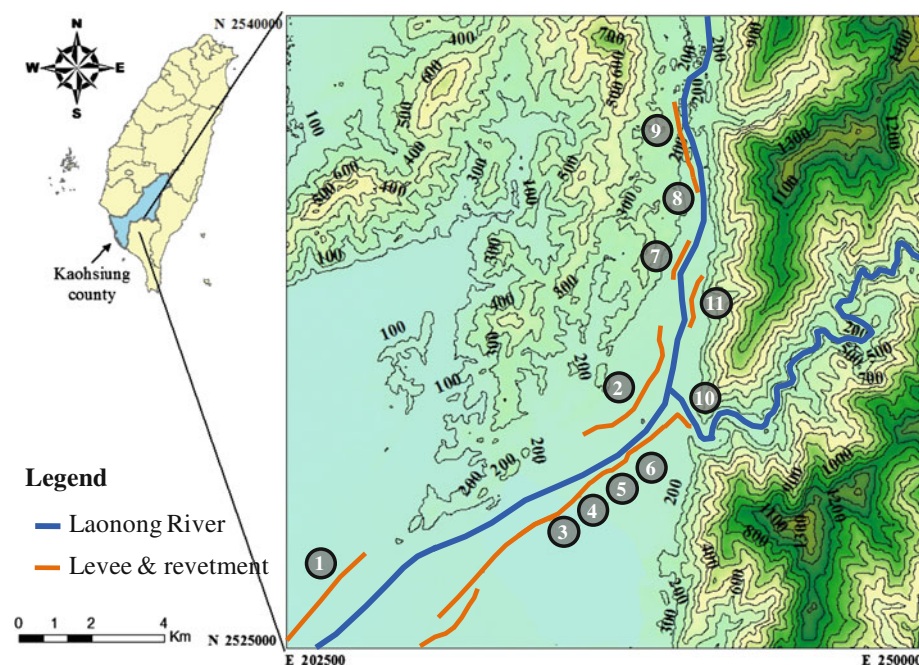
Fig. 1 Locations of levee breaches in the downstream area of the *Laonong River* after Typhoon Morakot. (Chiuliao first levee is in location No. 6, Liu et al. 2009)

Among the levee breaches above, the most serious disaster occurred at the Chiuliao first levee, which is located in Kaoshu village in Pintung County (No. 6 in Fig. 1). This levee was built on the left river bank near the confluence of the Laonong River and its branch, the Chokuo River. This levee is a gravity-type earthen levee with a height of approximately 10 m. During Typhoon Morakot, approximately 4,000 m of the levee broke away, providing an opening for water to scour the protected side of the structure (Fig. 2). Approximately 0.5 km² of agricultural area behind the levee was eroded and more than 20 houses were destroyed (Figs. 2, 3) (Li et al. 2009; Liu et al. 2009; Chang 2012). This event drew significant public attention to the issue of levee safety.

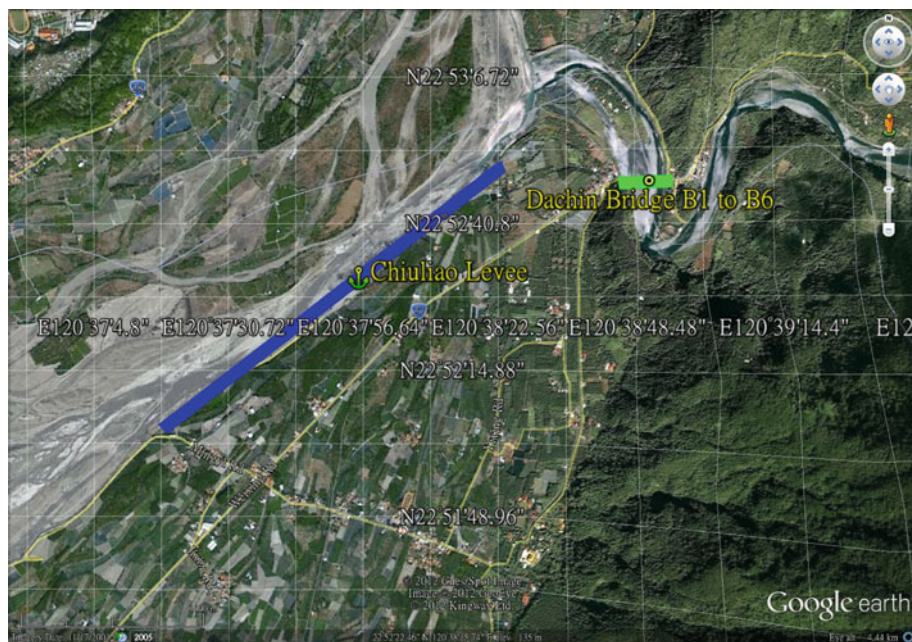
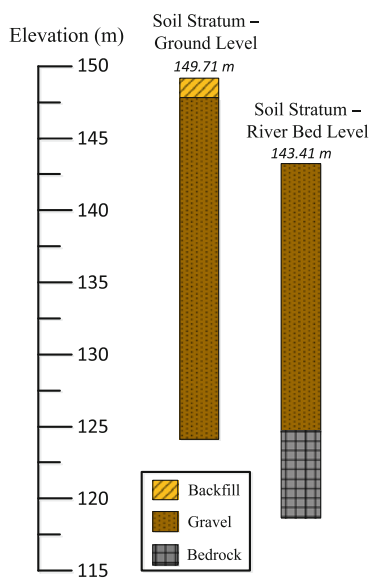
Fig. 4 Relative locations of soil borings and its soil profiles. **a** Locations of the Chiuliao first levee and soil borings; **b** generalized soil profiles close to the Chiuliao first levee

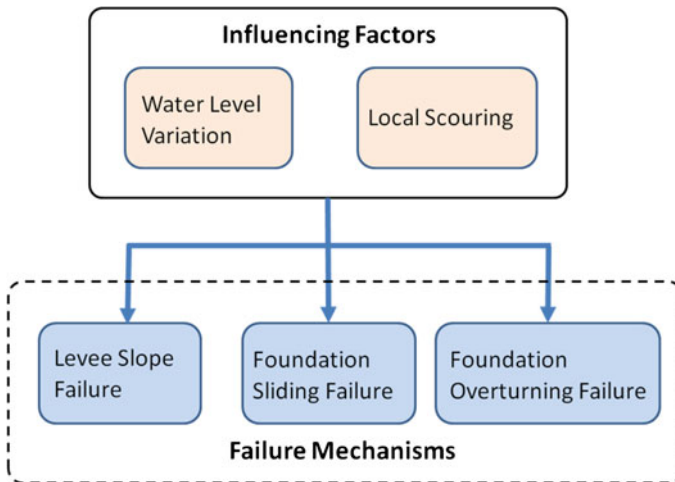
levee foundation because the passive forces that provide additional resistance forces decrease when scouring occurs. This causes the backfill in front of the levee foundation on the flood side to disappear. The levee automatically fails under this circumstance. In summary, the failure mechanisms analyzed in this study include (1) slope stability analysis (considering seepage flow and water-level variation) and (2) levee foundation stability analysis (including typical retaining wall analyses—sliding and overturning failure under various water-level conditions). This study does not consider bearing capacity failure because the in situ friction angle of the gravel is so high that the levee foundation is not prone to bearing capacity failure. Figure 7 shows the relationships between the failure-triggered factors and the failure mechanisms.

Fig. 7 Failure mechanisms considered in this study

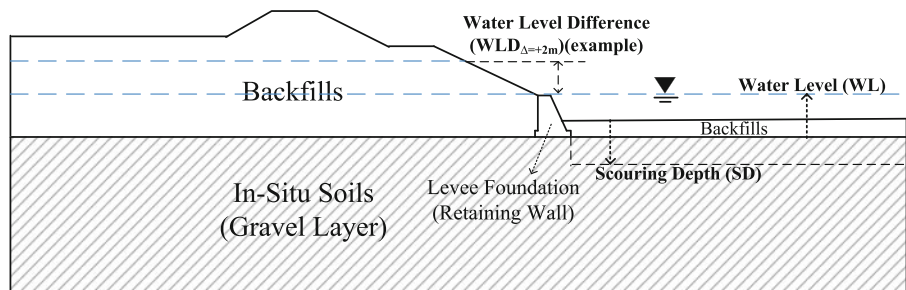
and scouring depth of the riverbed on the protected side. The water level is defined as the water height on the flood side from the in situ ground surface. Because there is difference between protected flood sides of the water level, the difference is termed as water-level difference. The scouring depth is defined as the height from the backfill surface on the flood side. Figure 8 shows these parameters to enable better comprehension of the analyzed cases.

Fig. 8 Illustration of the levee stability analysis parameters: water level (WL), water-level difference (WLD), and scouring depth (SD)

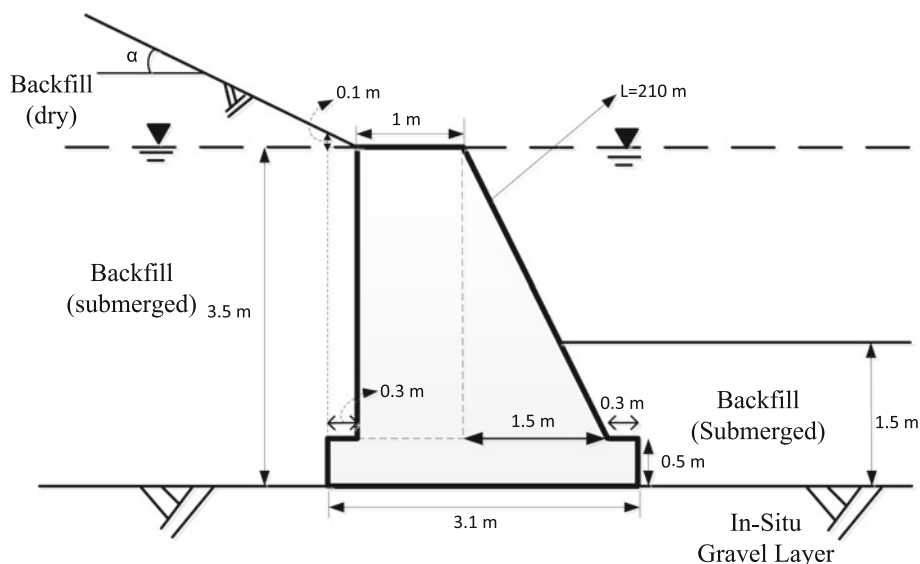
As mentioned previously, we also analyzed the levee foundation (as a retaining wall) based on sliding and overturning failure mechanisms. Figure 9 shows the dimensions of the levee foundation. Several external forces act on the foundations. On the left side of the foundation, there is active earth pressure and water pressure. On the right side of the foundation, there is passive earth pressure and water pressure. On the bottom of the foundation, there is uplift force caused by pore-water pressure. To determine the pore-water pressure distribution when the water level heights at both sides of the foundation are different (thus inducing seepage), we used SEEP/W to obtain the pore-water pressure distribution under the foundation. The foundation was considered to be sliding when the horizontal driving forces exceeded the horizontal resistance forces. Overturning of the foundation was considered through the resistance moment against the driving moments with respect to the toe of the levee foundation. The weight of the foundation was calculated based on the design cross section of the levee system.

Fig. 9 Schematic illustration of the levee foundation cross section
